## Plant Colonisation on OSA Coastal Environments

### Bladder Wrack on OSA

On 15th and 16<sup>th</sup> June 2020 site visits were made to several sites where OSA has been used in a saline environment. One site was in Suffolk and the rest in Essex.

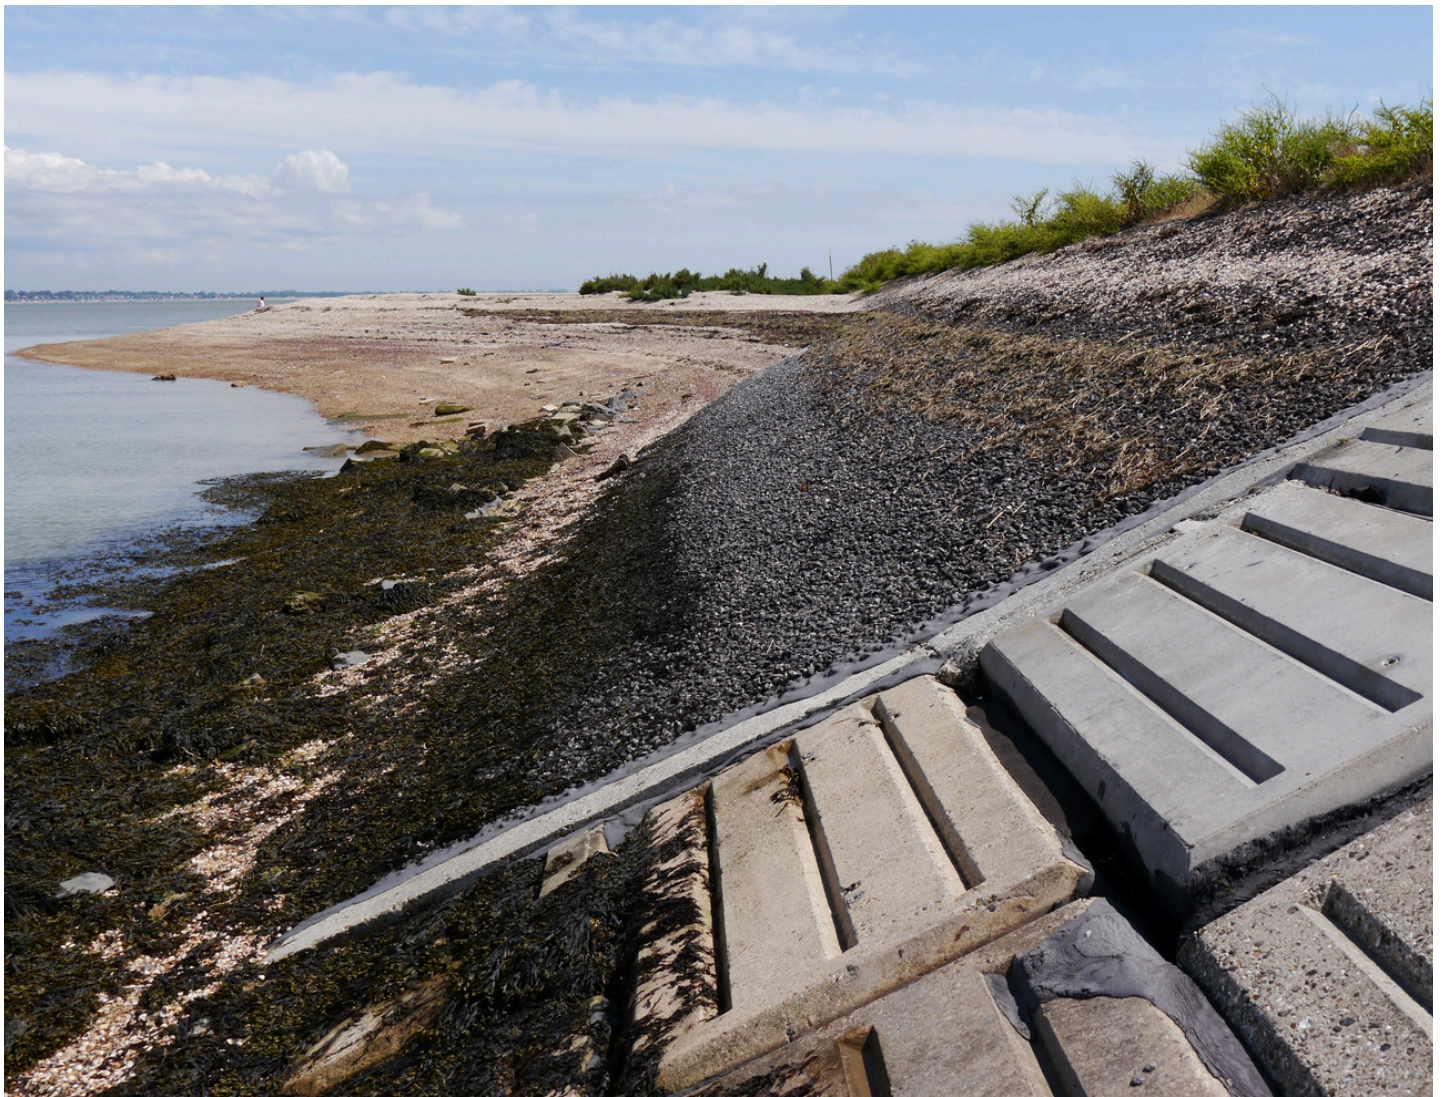
| Photo Ref | Location | Date Installed | Material | Notes |
|---|---|---|---|---|
| Brad-A | Bradwell Power Station, Essex | November 2016 | 20-32mm OSA | Bladder Wrack on OSA where mobile beach material finishes |

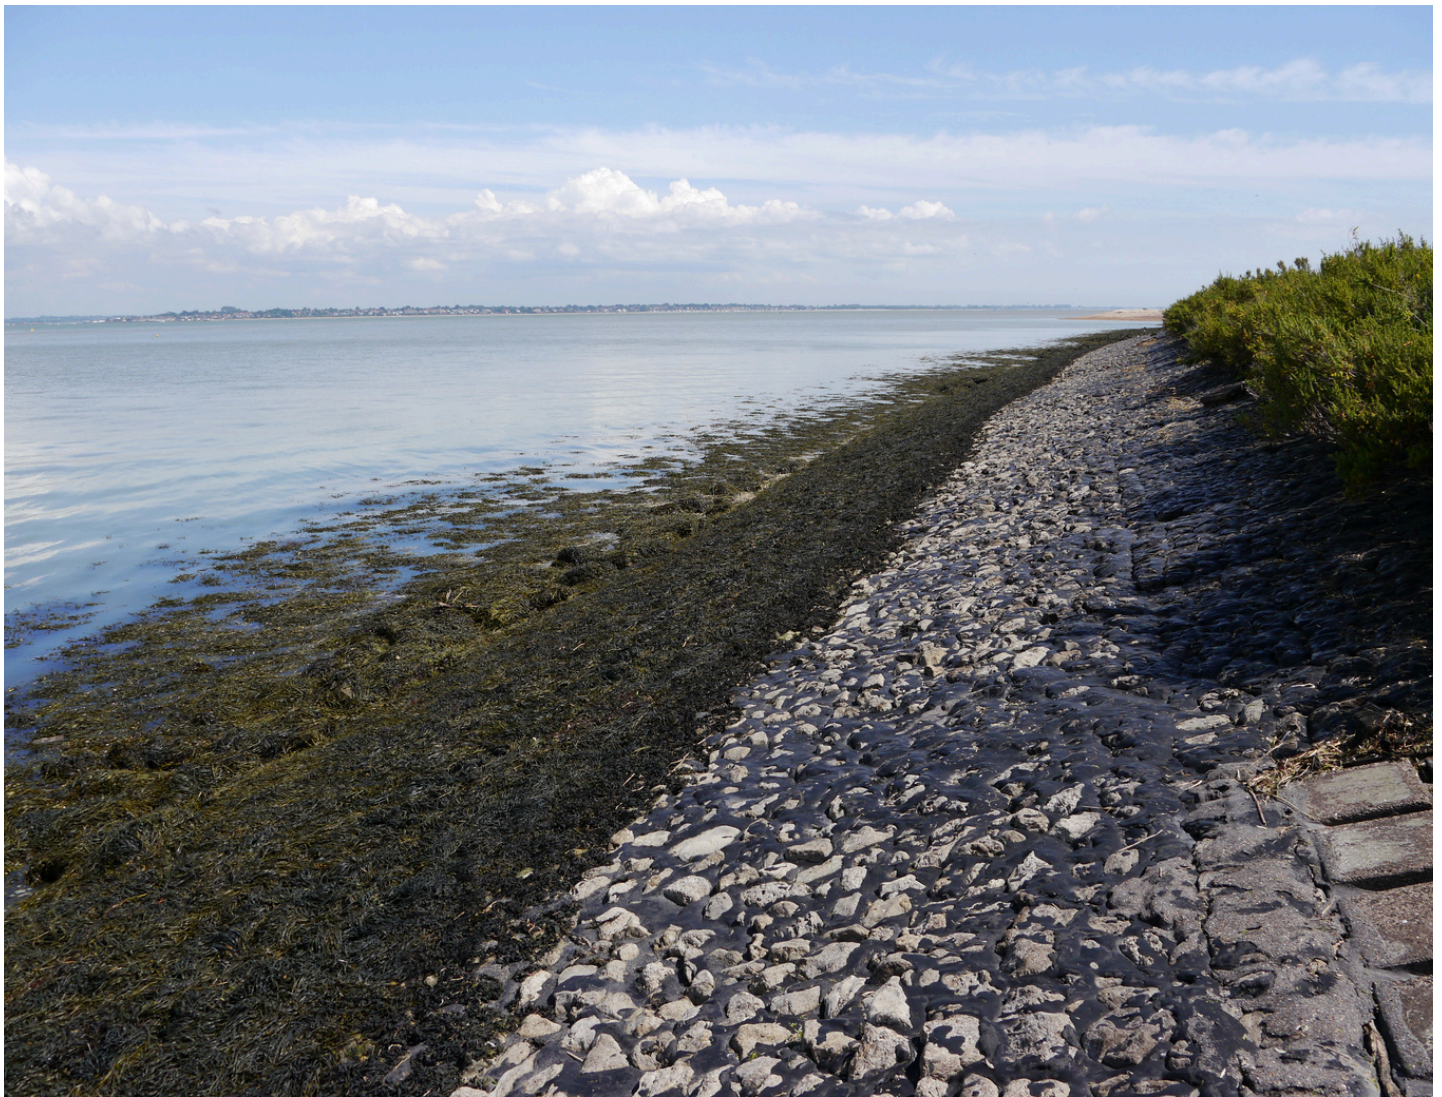
| Photo Ref | Location | Date Installed | Material | Notes |
|---|---|---|---|---|
| Brad-B | Bradwell Power Station, Essex | Not known | Grouted rock | Bladder Wrack on old grouted rock |

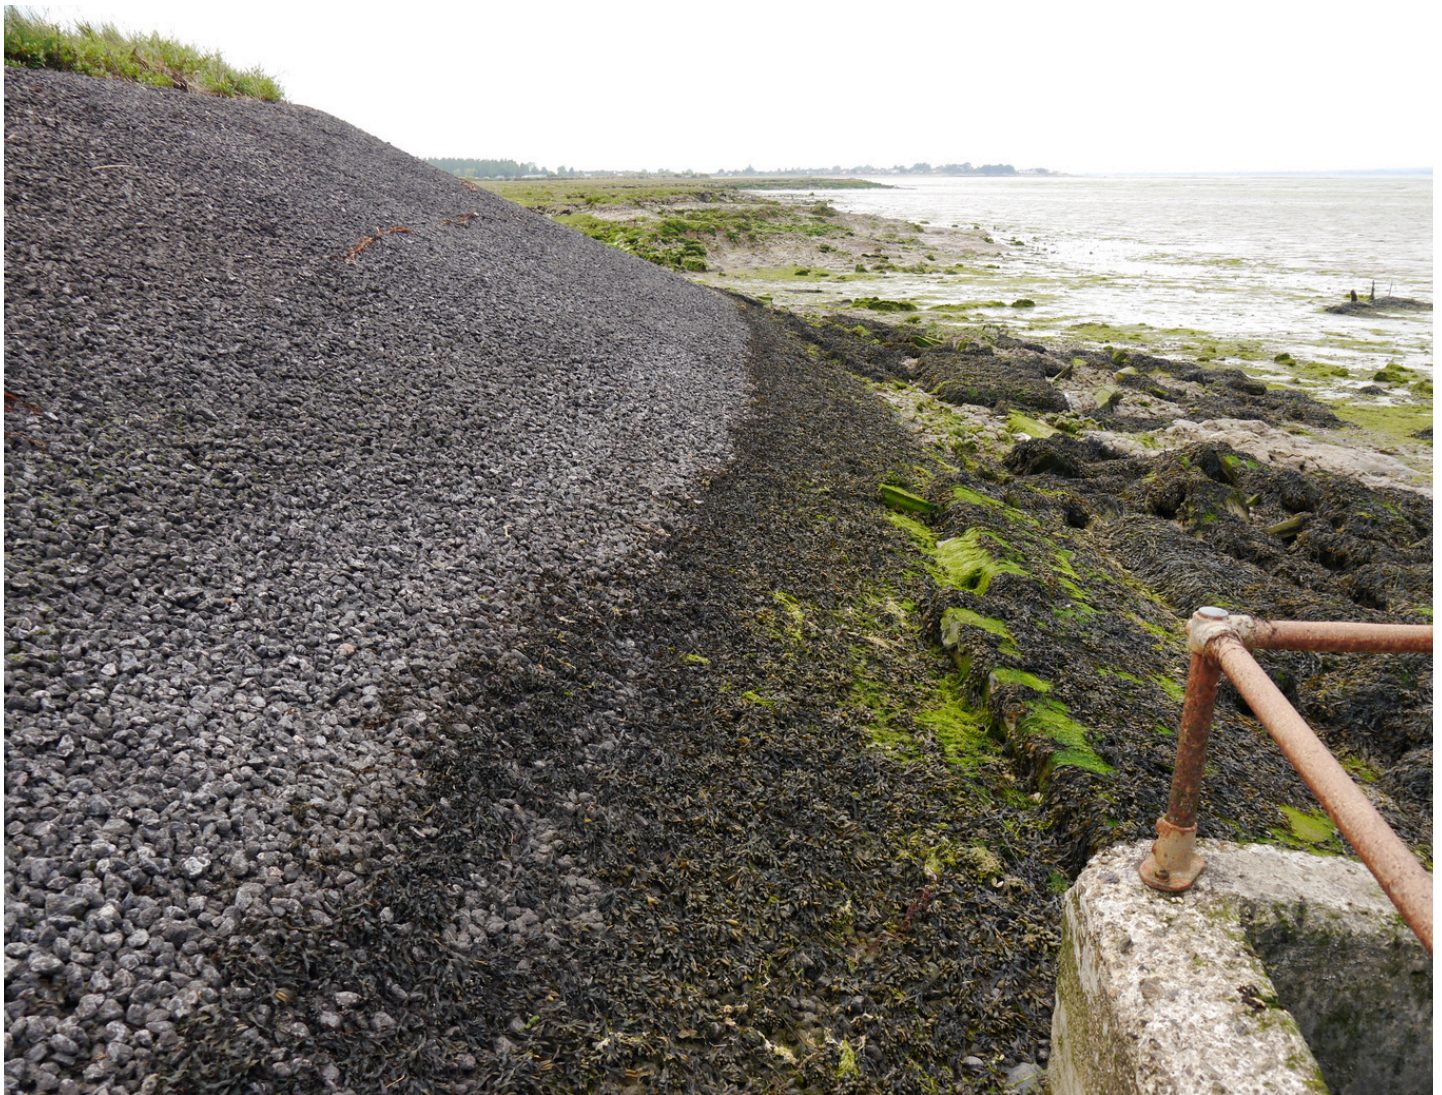
| Photo Ref | Location | Date Installed | Material | Notes |
|---|---|---|---|---|
| Brad W-A | Bradwell Wick, Essex | October 2016 | 20-32mm OSA | Bladder Wrack well established along lower part of revetment |

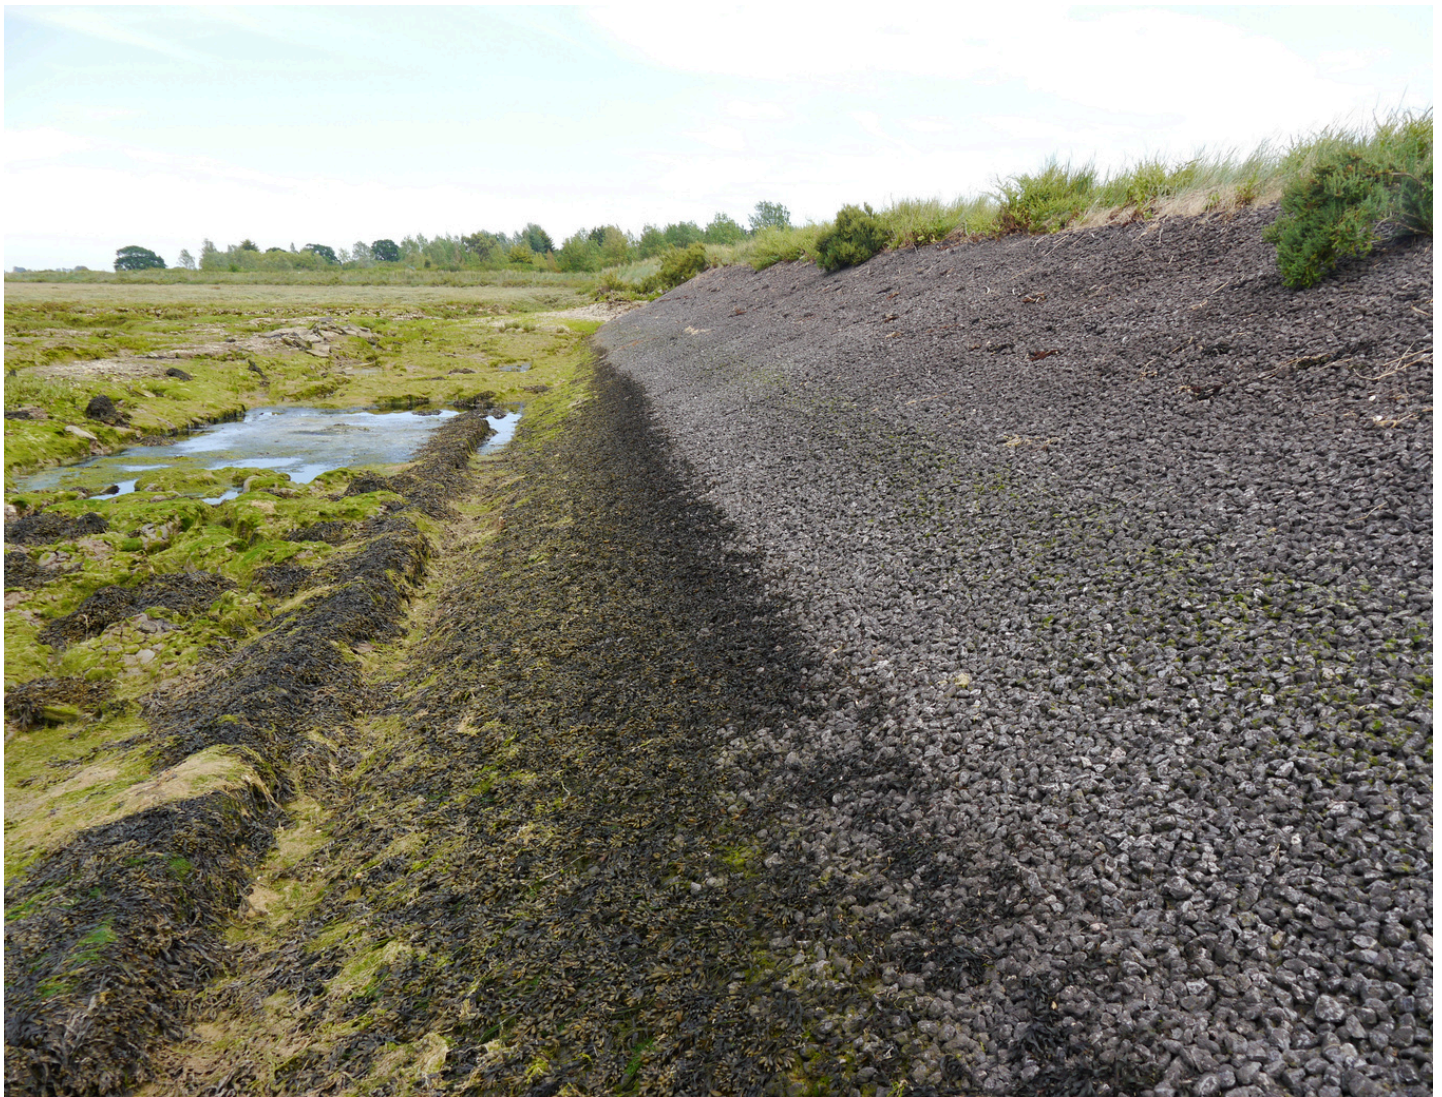
| Photo Ref | Location | Date Installed | Material | Notes |
|---|---|---|---|---|
| Brad W-B | Bradwell Wick, Essex | October 2016 | 20-32mm OSA | Bladder Wrack well established along lower part of revetment |

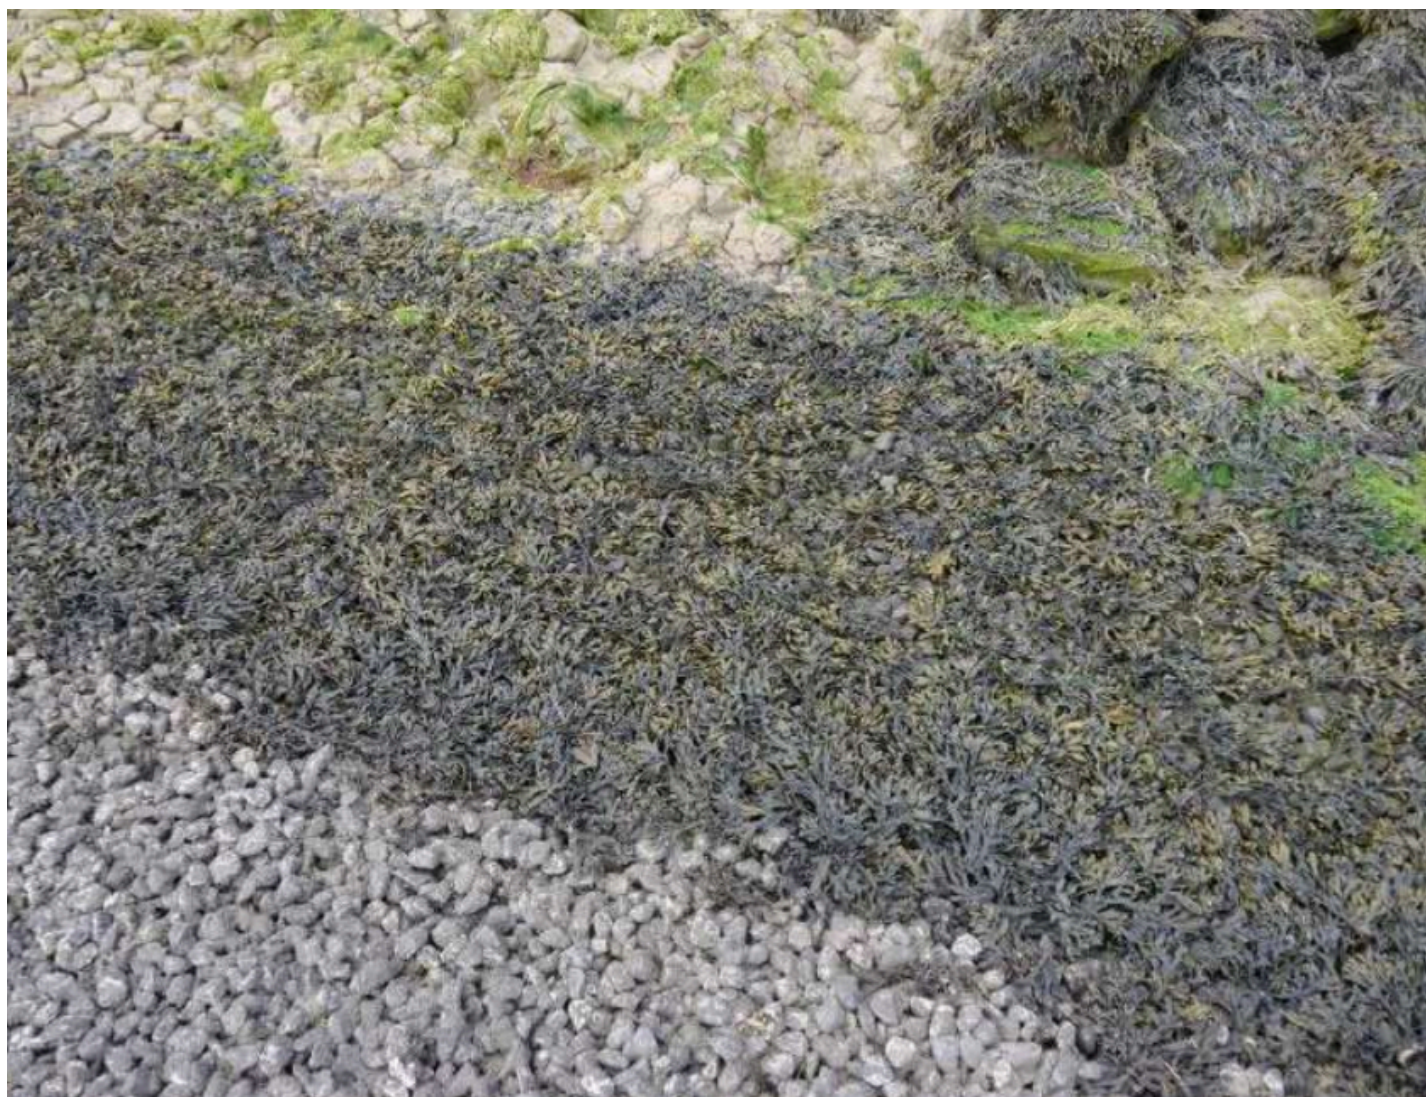
| Photo Ref | Location | Date Installed | Material | Notes |
|---|---|---|---|---|
| Brad W-C | Bradwell Wick, Essex | October 2016 | 20-32mm OSA | Close up of lower part of revetment |

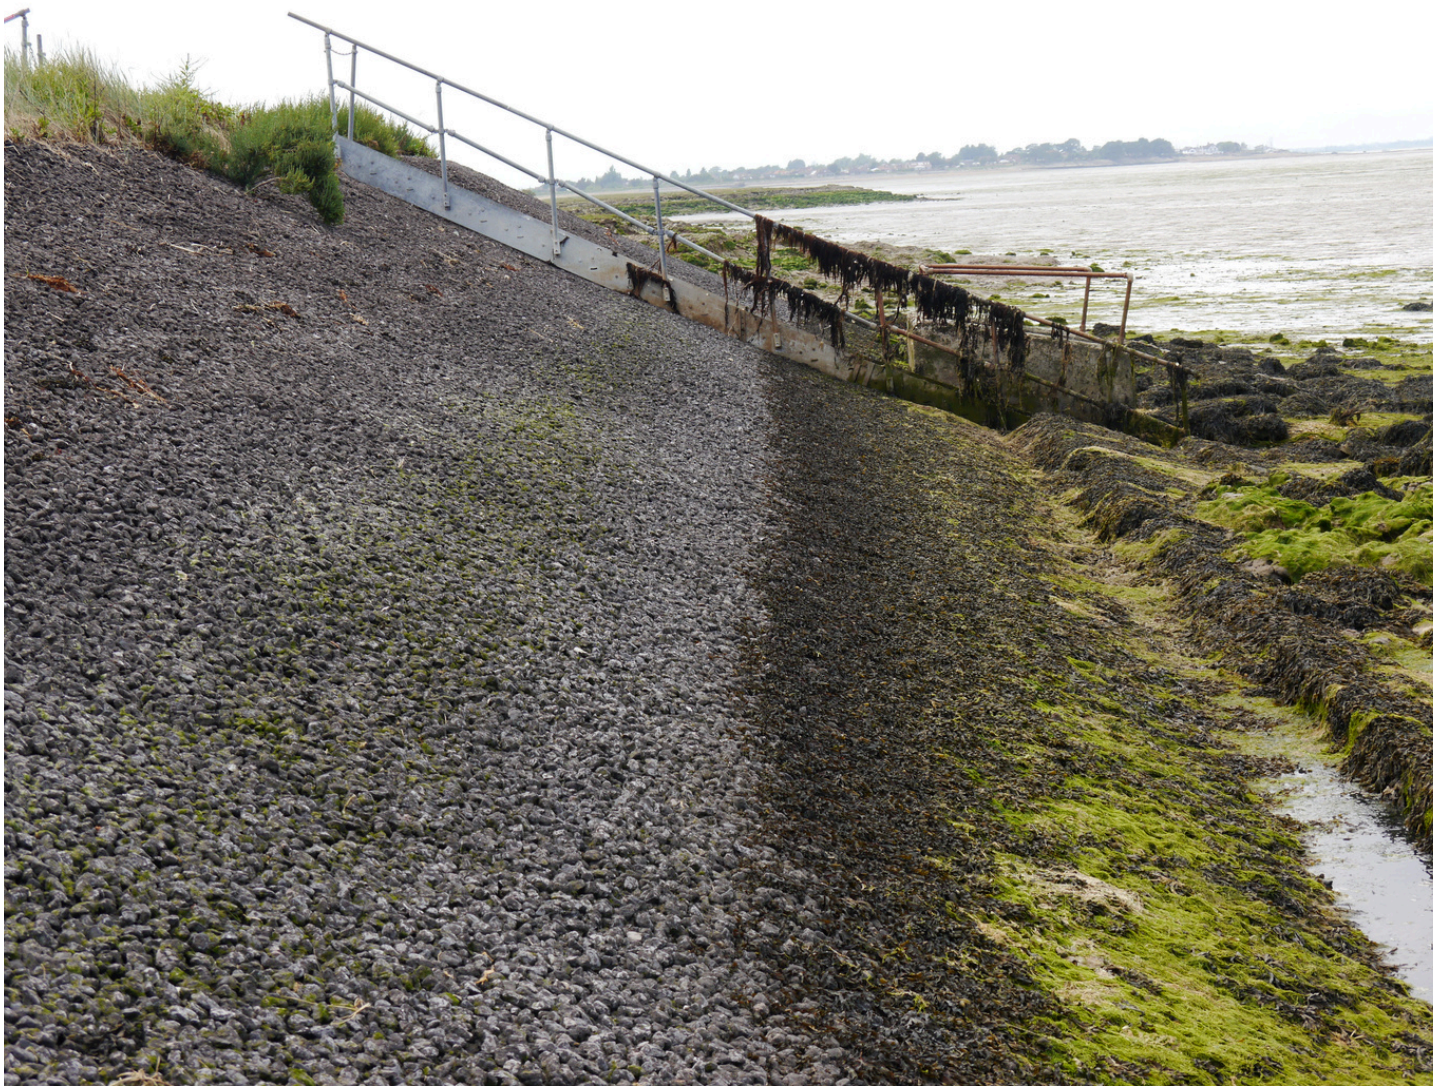
| Photo Ref | Location | Date Installed | Material | Notes |
|---|---|---|---|---|
| Brad W-D | Bradwell Wick, Essex | October 2016 | 20-32mm OSA | Bladder Wrack well established along lower part of revetment |

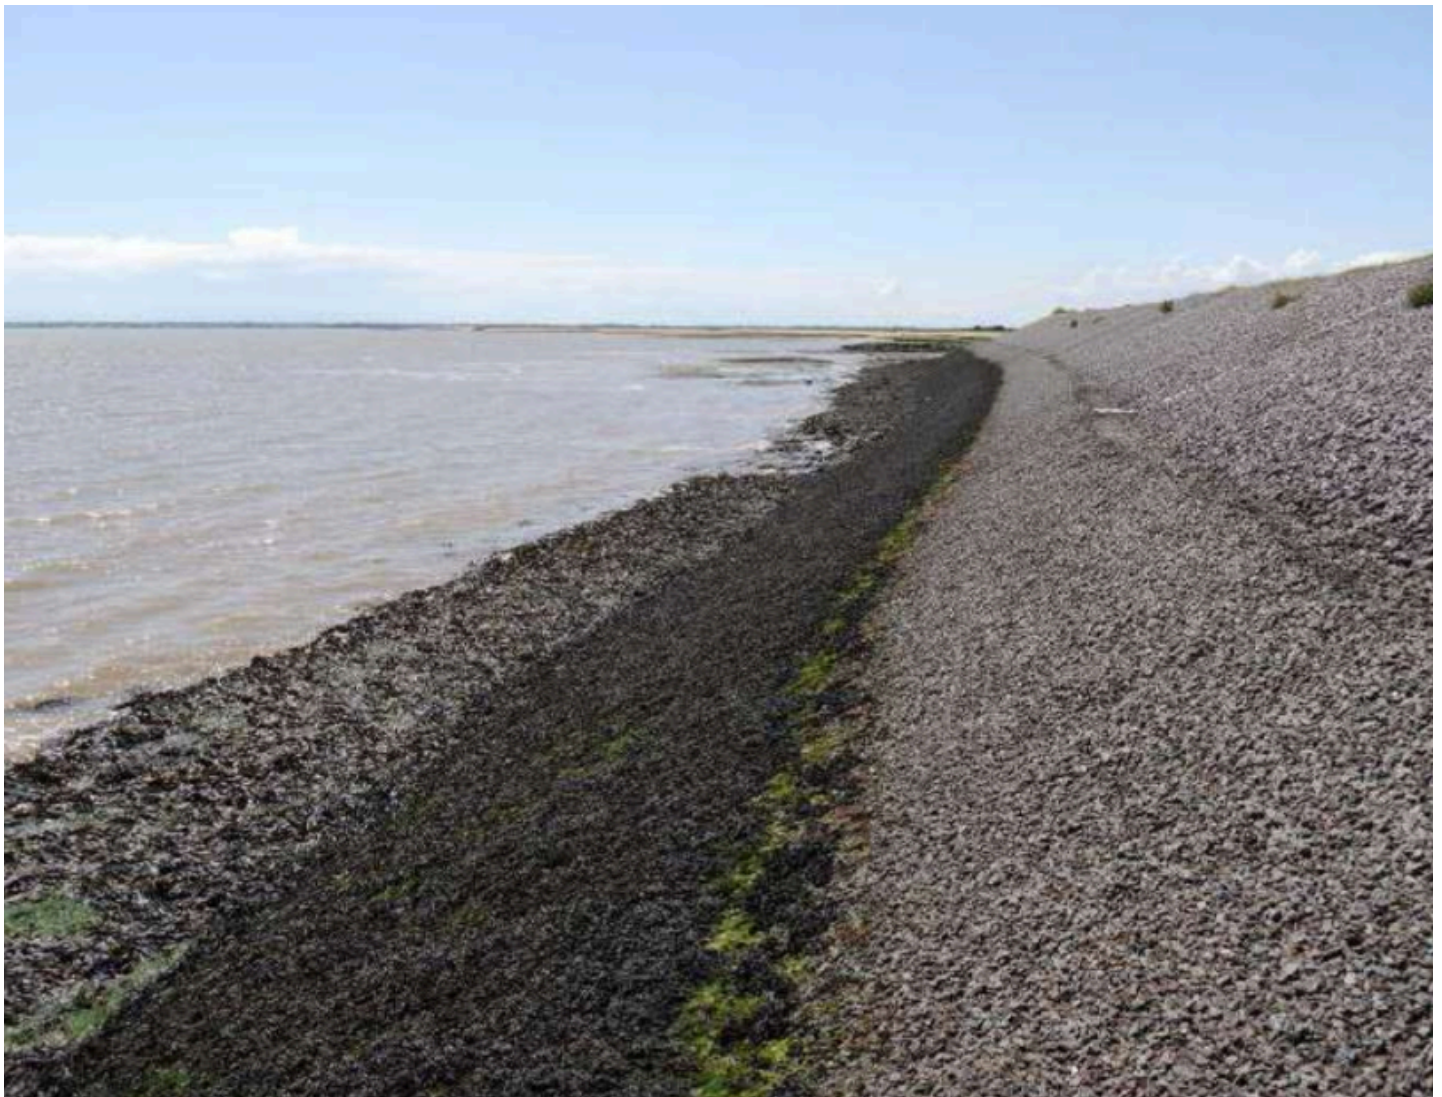
| Photo Ref | Location | Date Installed | Material | Notes |
|---|---|---|---|---|
| Dov - A | Dovercourt, Essex | October 2010 | 10-20mm Elastocoast on 20-32mm OSA | A 50mm layer of Elastocoast was placed on a 20-32mm OSA layer. Bladder Wrack very well established |

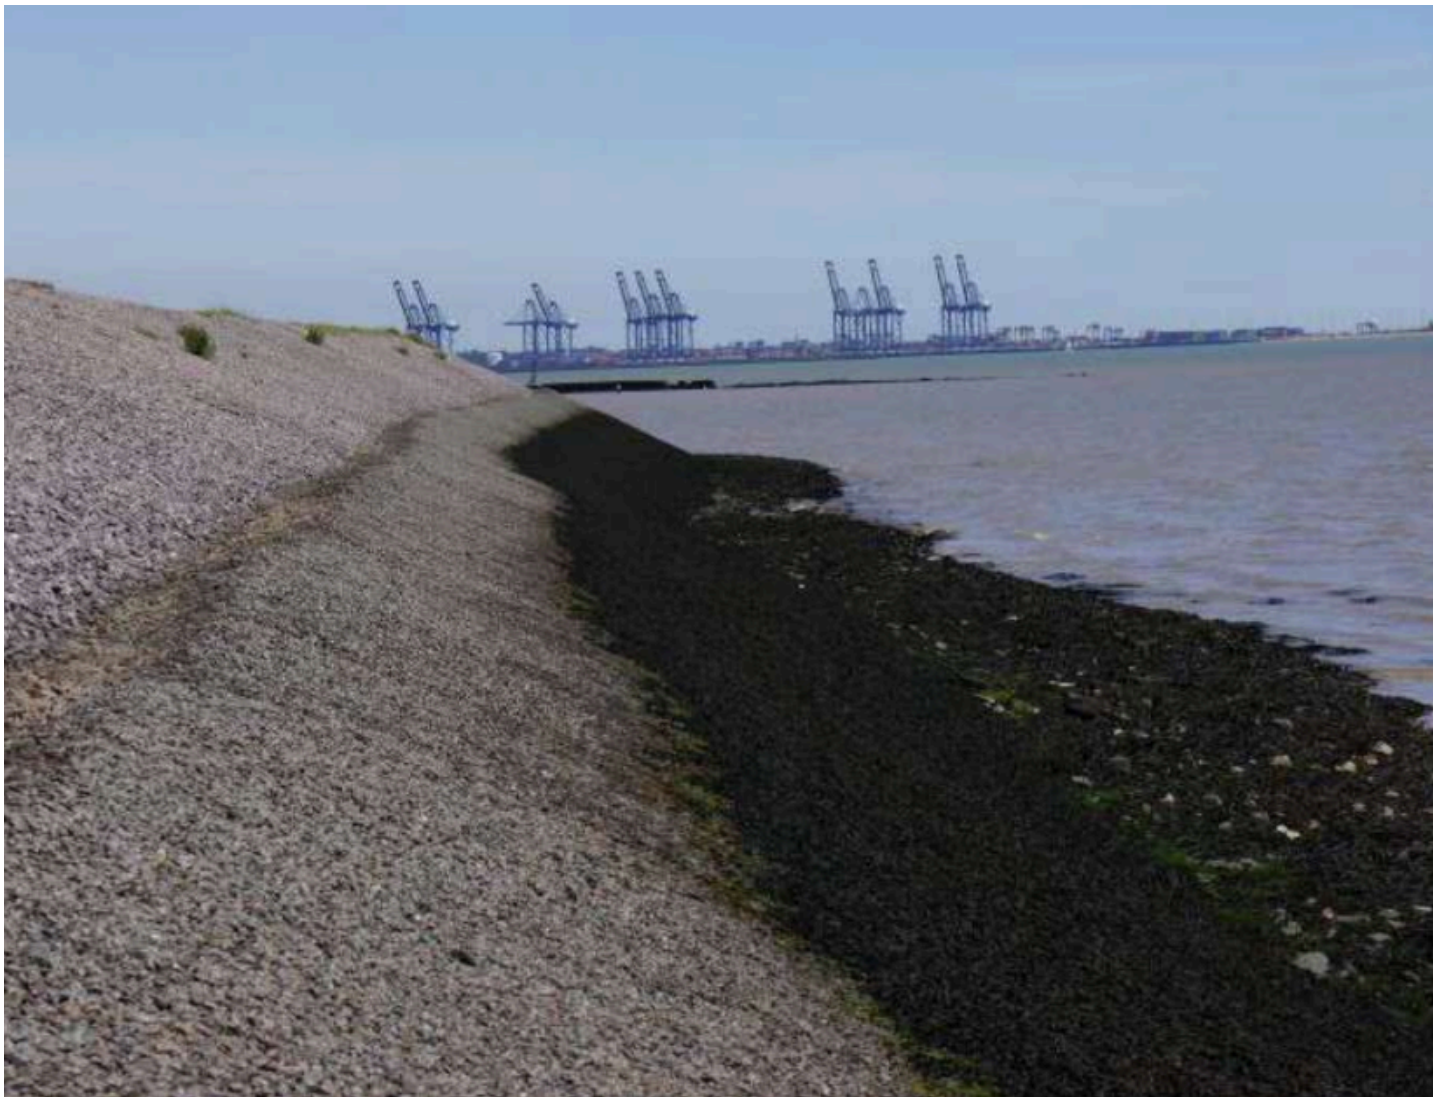
| Photo Ref | Location | Date Installed | Material | Notes |
|---|---|---|---|---|
| Dov - B | Dovercourt, Essex | October 2010 | 10-20mm Elastocoast on 20-32mm OSA | A 50mm layer of Elastocoast was placed on a 20-32mm OSA layer. Bladder Wrack very well established |

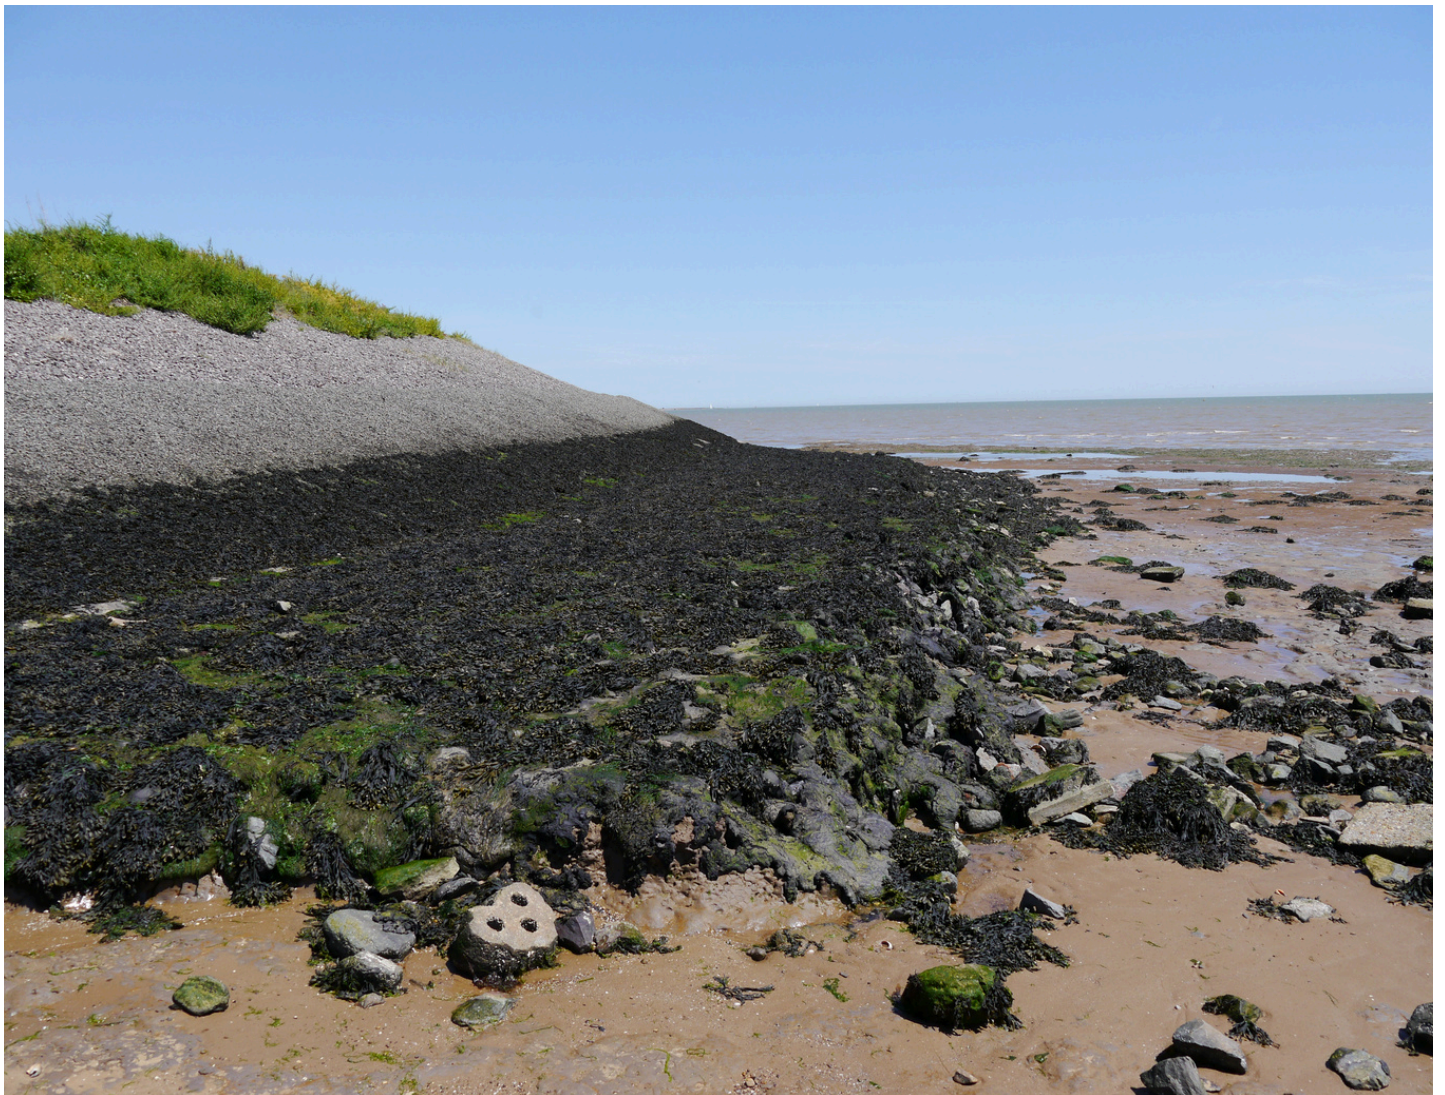
| Photo Ref | Location | Date Installed | Material | Notes |
|---|---|---|---|---|
| Dov - C | Dovercourt, Essex | March 2002 | Grouted Rock Toe | Bladder Wrack well established on grouted rock toe |

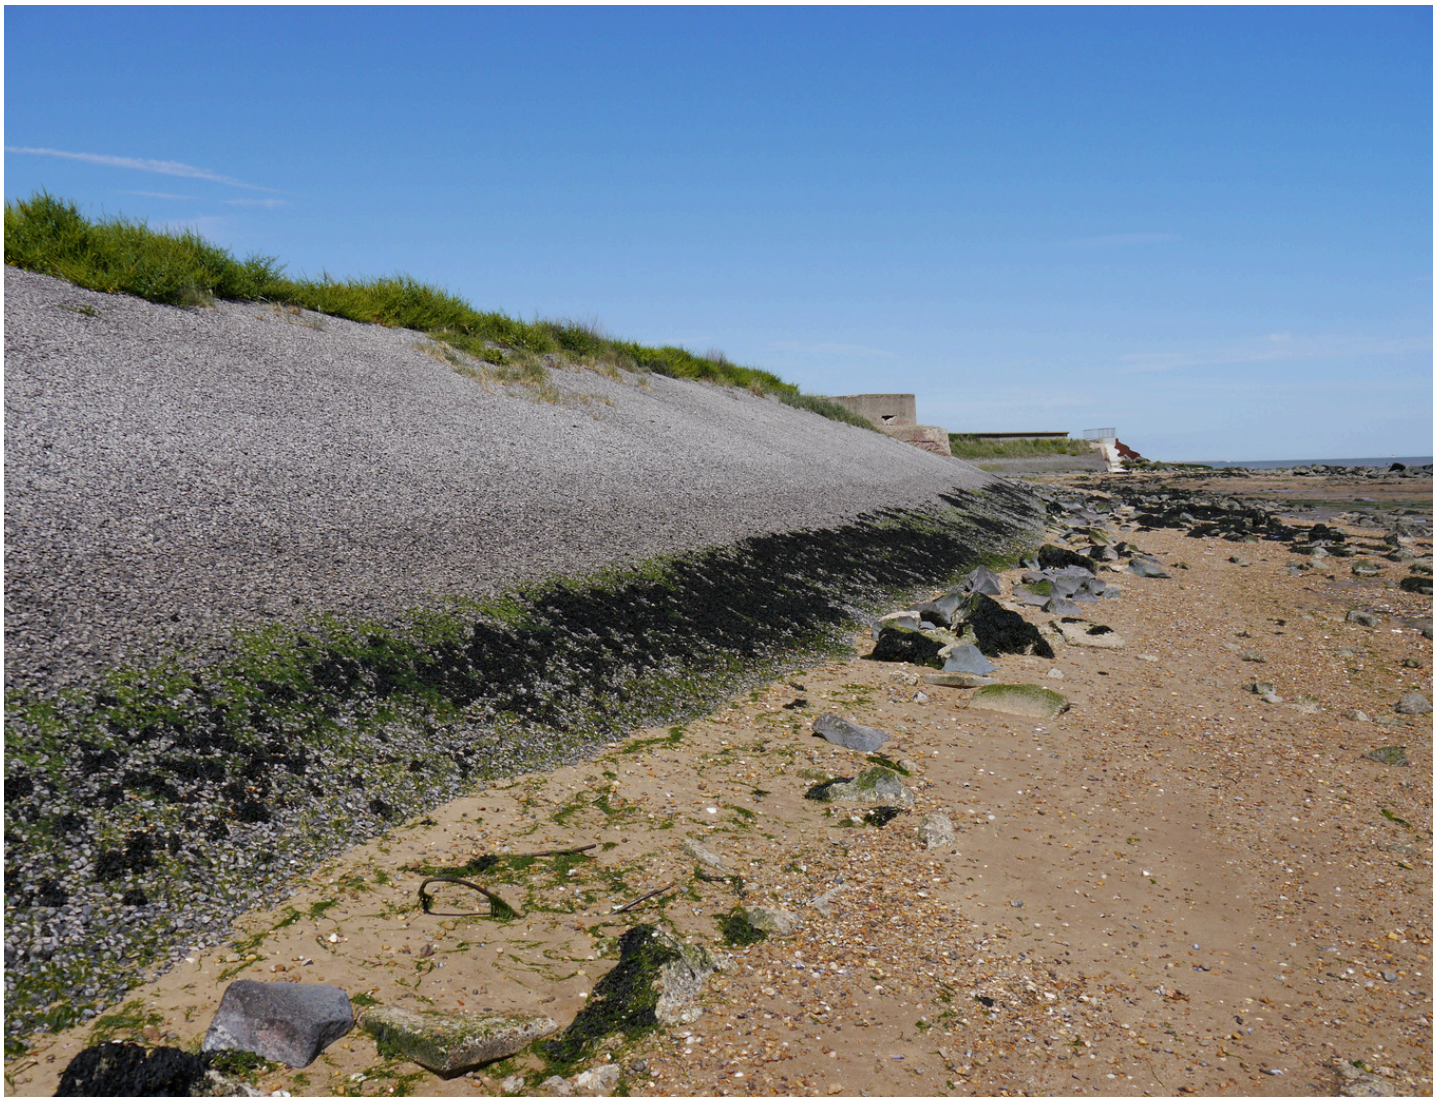
| Photo Ref | Location | Date Installed | Material | Notes |
|---|---|---|---|---|
| F Hall-A | Foulton Hall, Little Oakley, Essex | September 2009 | 20-32mm OSA | Bladder Wrack at toe - patchy due to mobile foreshore |

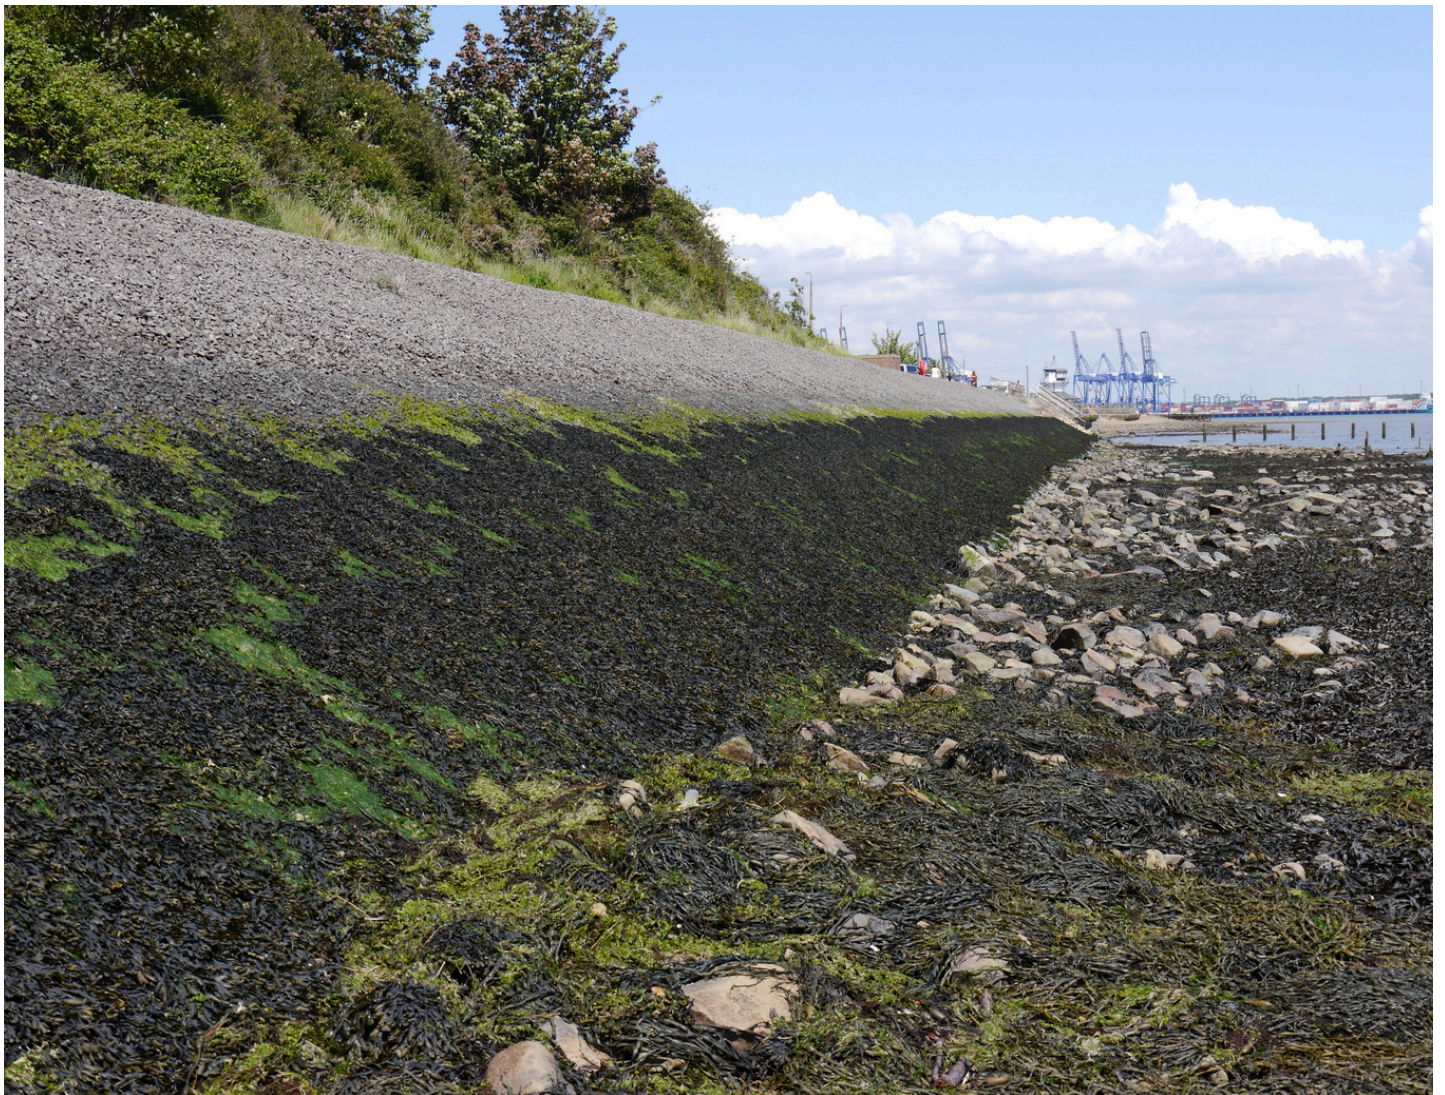
| Photo Ref | Location | Date Installed | Material | Notes |
|---|---|---|---|---|
| Har -A | Harwich, Essex | October 2003 | 20-32mm OSA | Bladder Wrack well established along lower part of revetment |

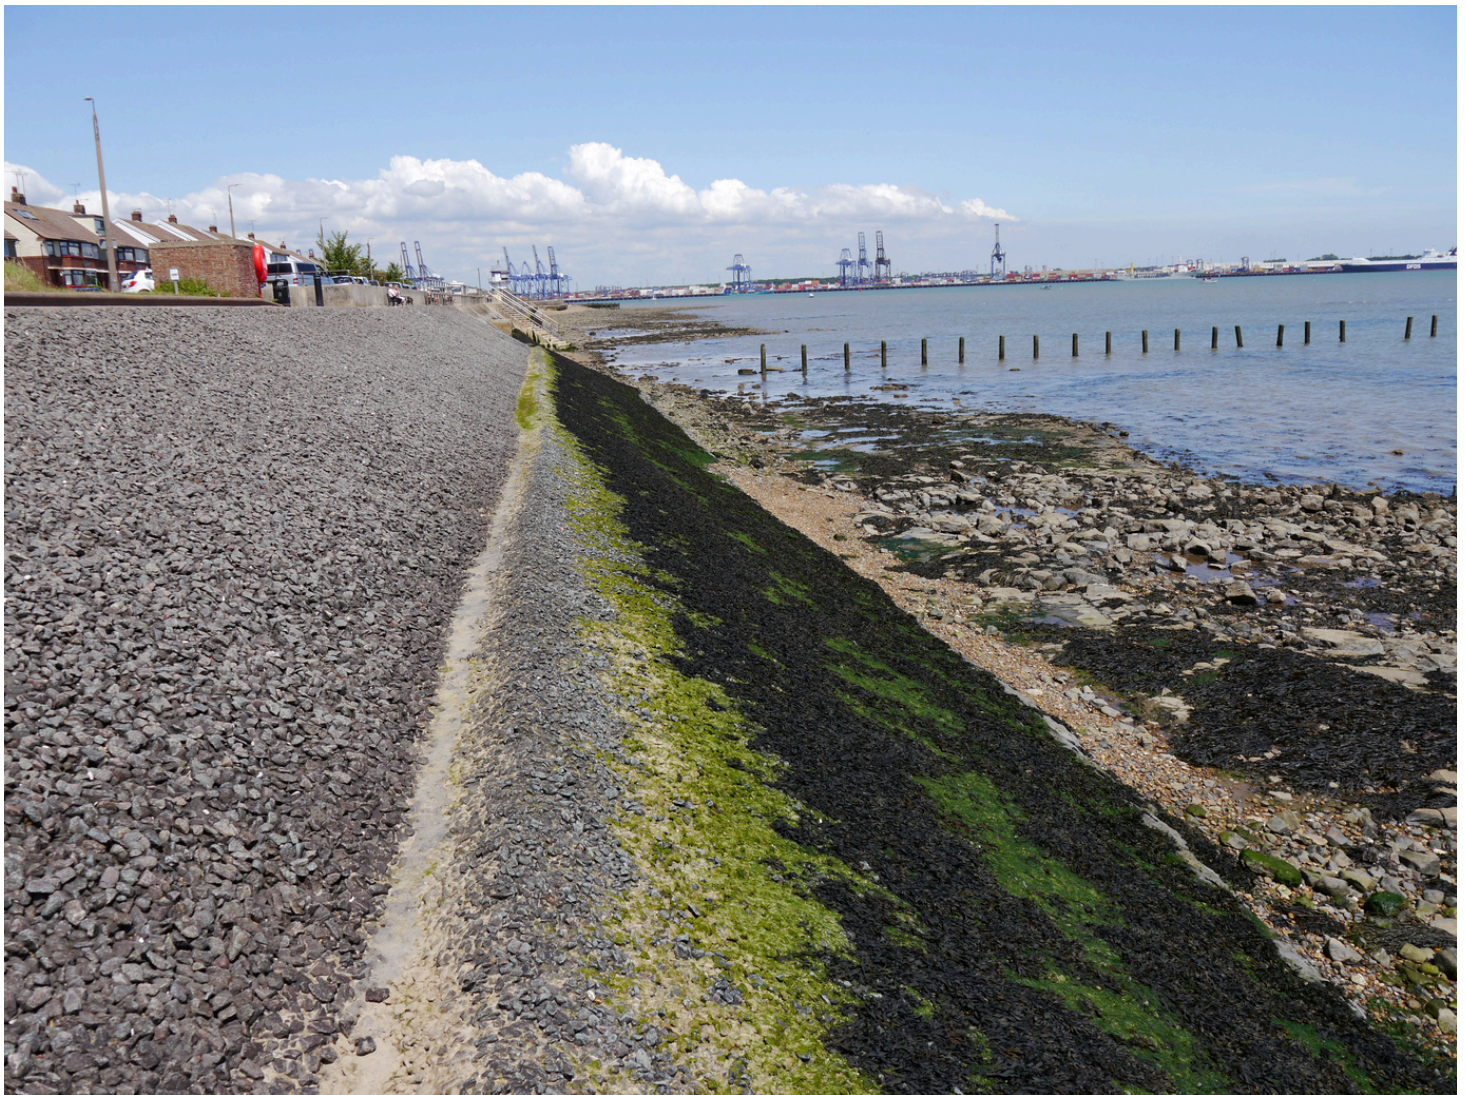
| Photo Ref | Location | Date Installed | Material | Notes |
|---|---|---|---|---|
| Har - B | Harwich, Essex | October 2003 | 20-32mm OSA | Bladder Wrack well established. Note grading difference between upper area (20-40mm) and lower area (20-32mm) |

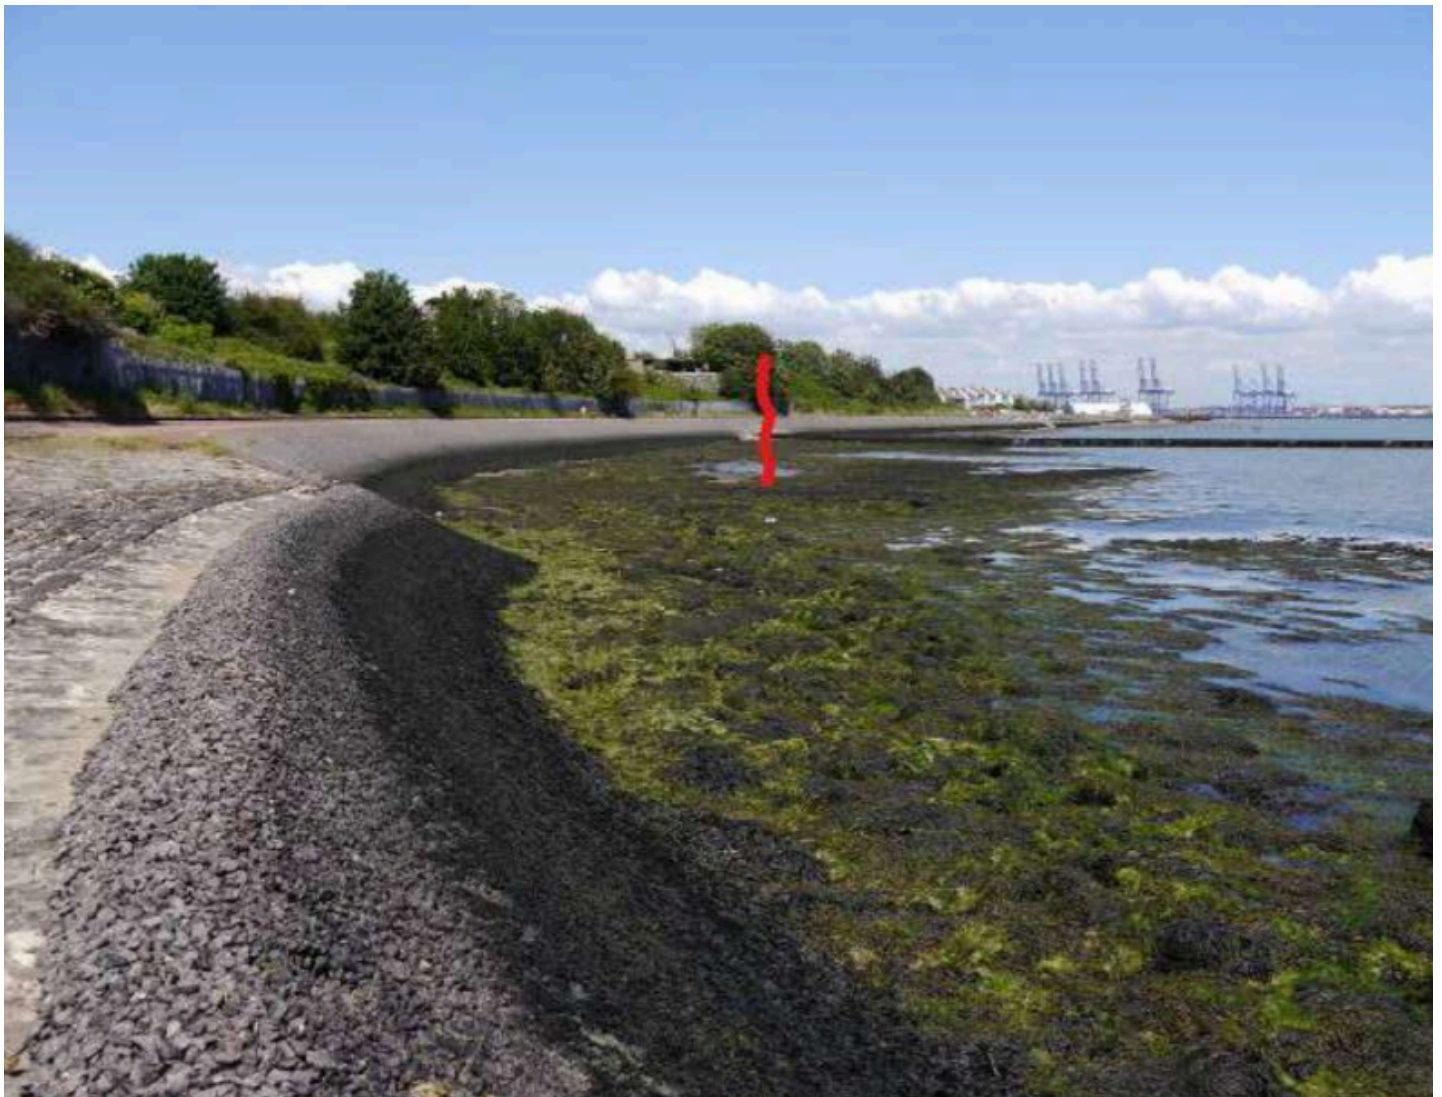
| Photo Ref | Location | Date Installed | Material | Notes |
|---|---|---|---|---|
| Har - C | Harwich, Essex | April 1997 -<br>October<br>2003 | 20-40mm<br>&<br>20-32mm<br>OSA | Near area to the left of the red line is 20-40mm OSA, far area to right of red line is 20-32mm OSA. Similar amount of established Bladder Wrack |

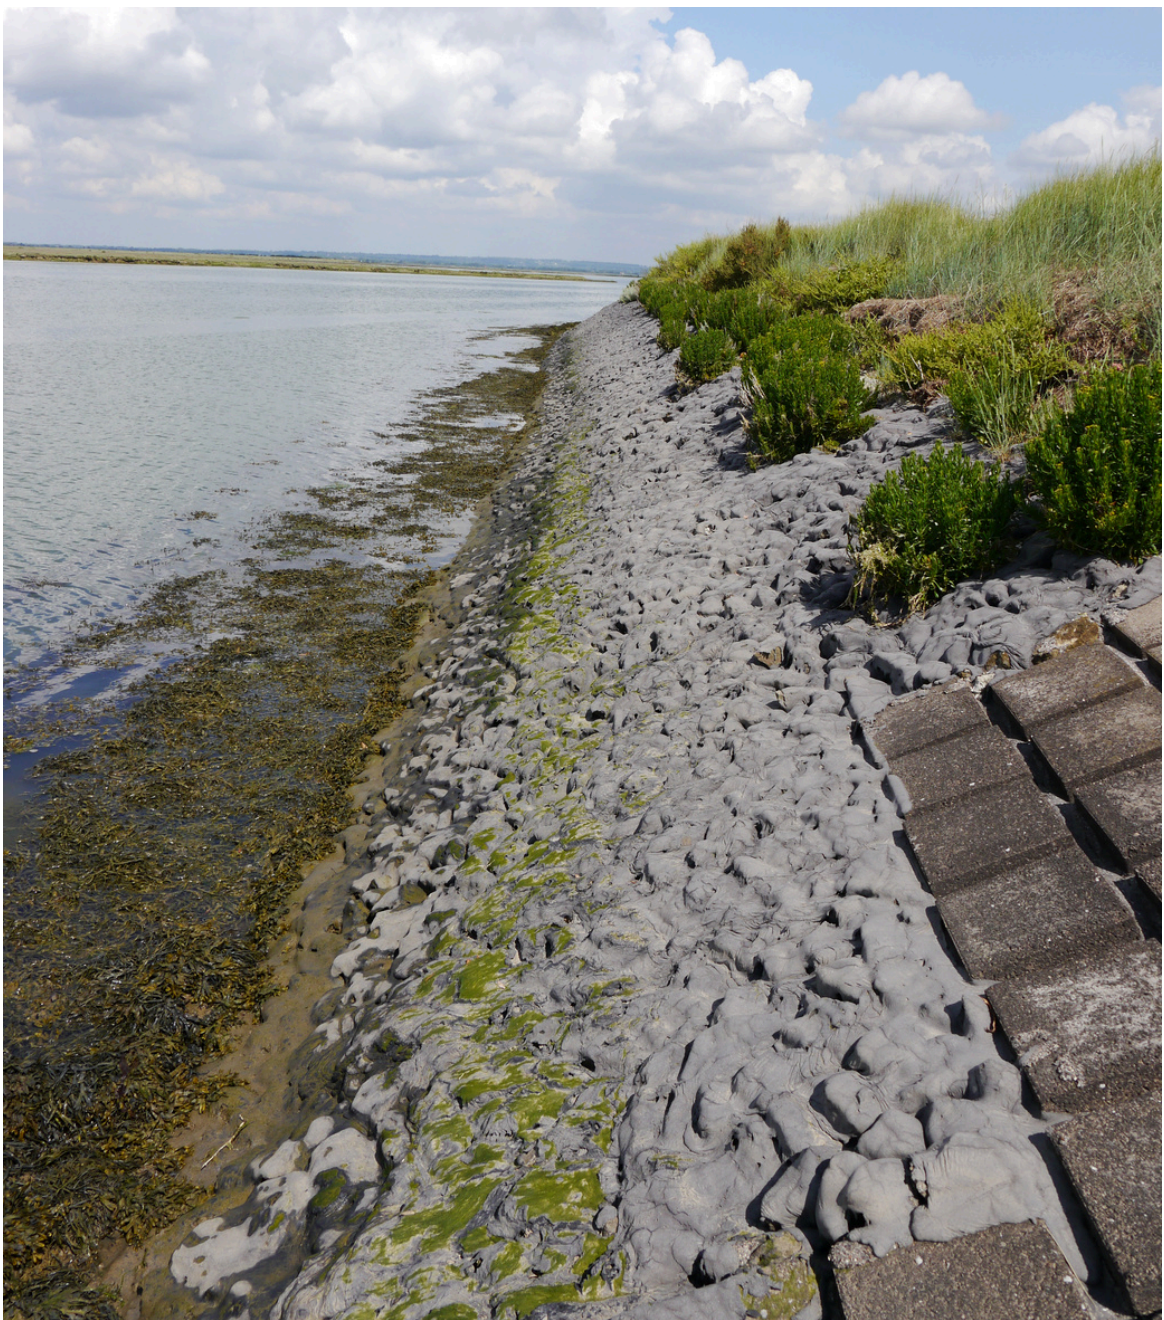
| Photo Ref | Location | Date Installed | Material | Notes |
|---|---|---|---|---|
| Steep -A | Steeple Bay, Essex | September 2016 | 20-32mm OSA | Bladder Wrack well established along lower part of revetment |
