## Plant Colonisation on OSA Coastal Environments

### Bladder Wrack on OSA

On 15th and 16<sup>th</sup> June 2020 site visits were made to several sites where OSA has been used in a saline environment. One site was in Suffolk and the rest in Essex.

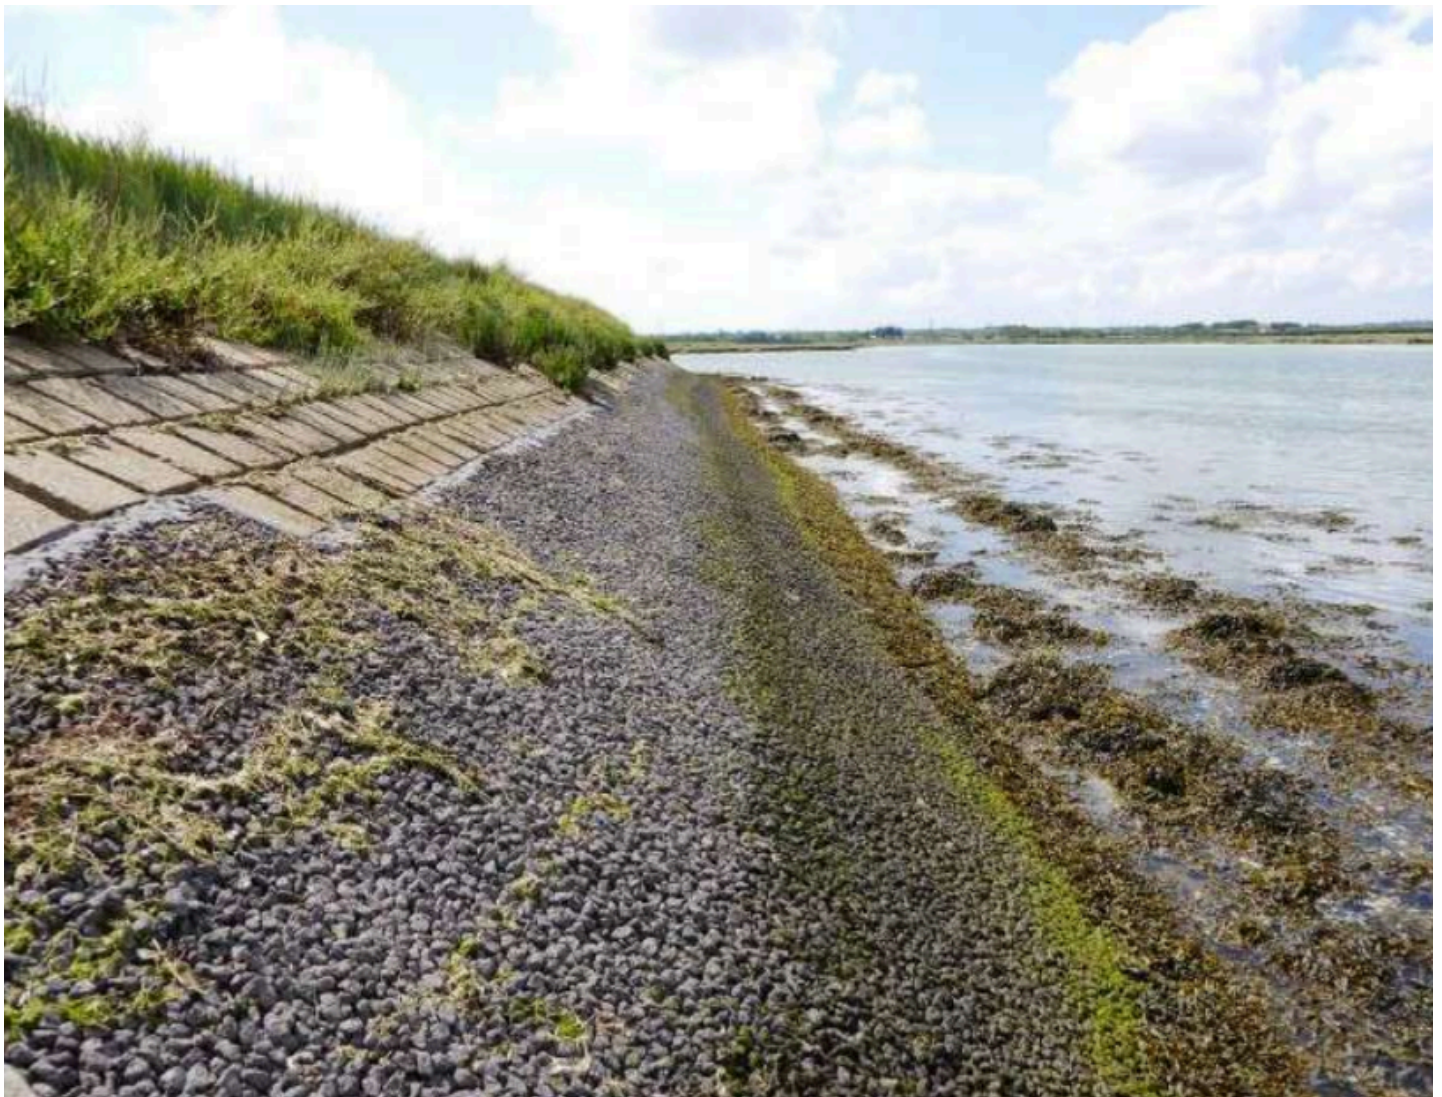
| Photo Ref | Location | Date Installed | Material | Notes |
|---|---|---|---|---|
| Steep -B | Steeple Bay, Essex | September 2016 | 20-32mm OSA | Bladder Wrack well established along lower part of revetment |

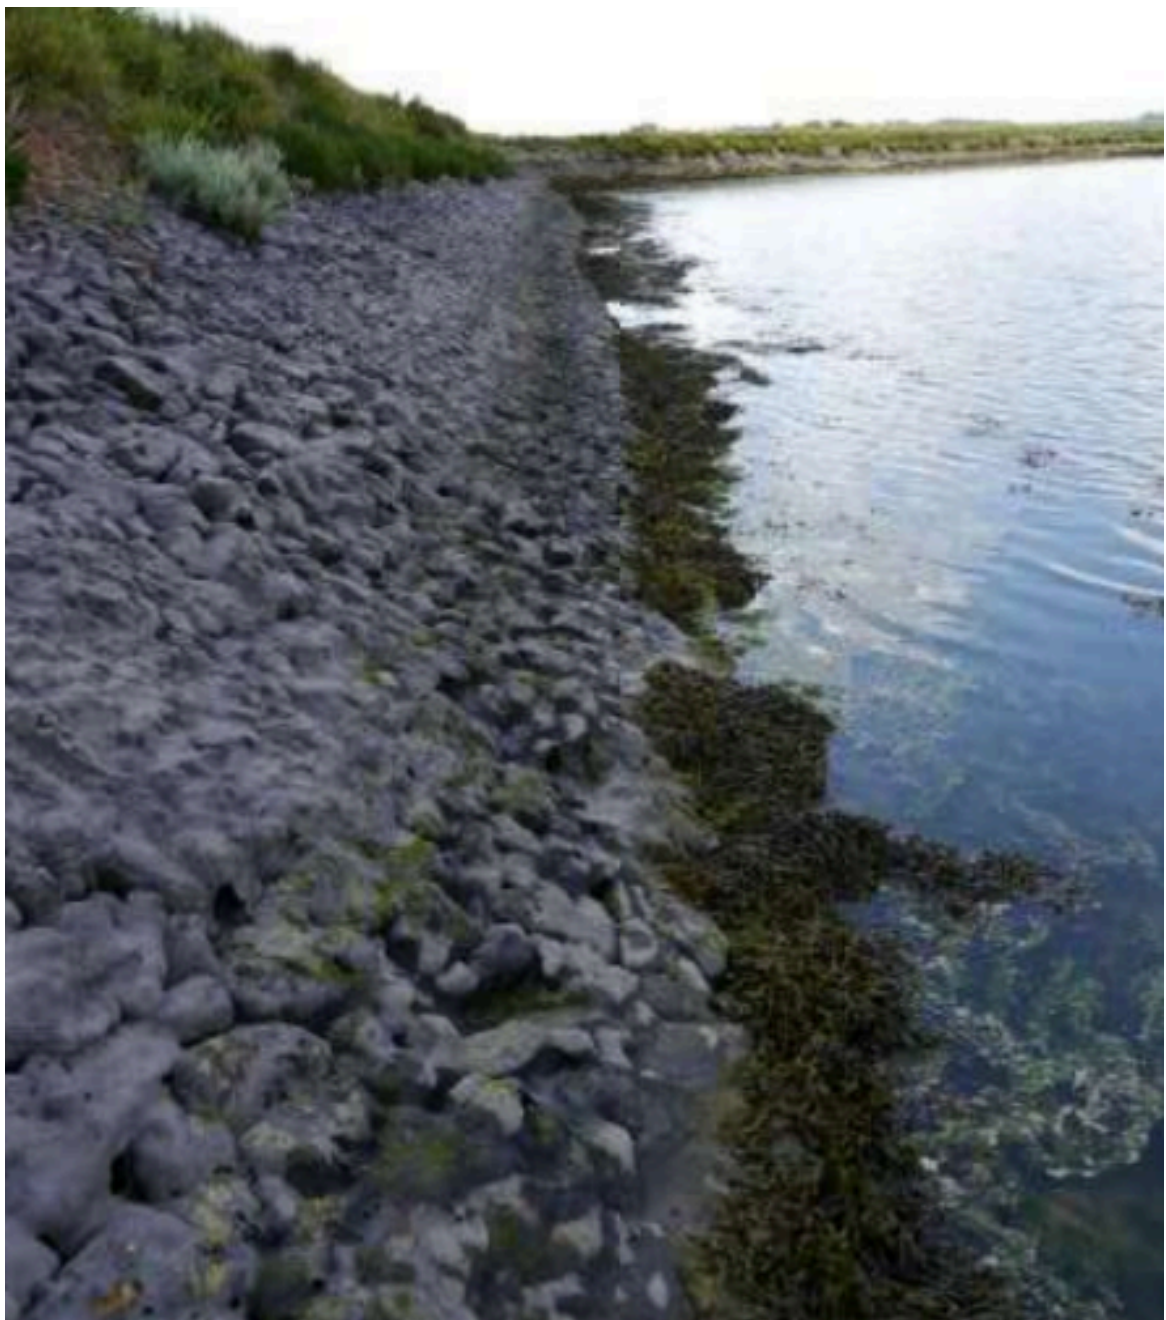
| Photo Ref | Location | Date Installed | Material | Notes |
|---|---|---|---|---|
| Steep - C | Steeple Bay, Essex | September 2016 | Grouted Rock | Bladder Wrack at toe of grouted rock revetment (4 years old) |

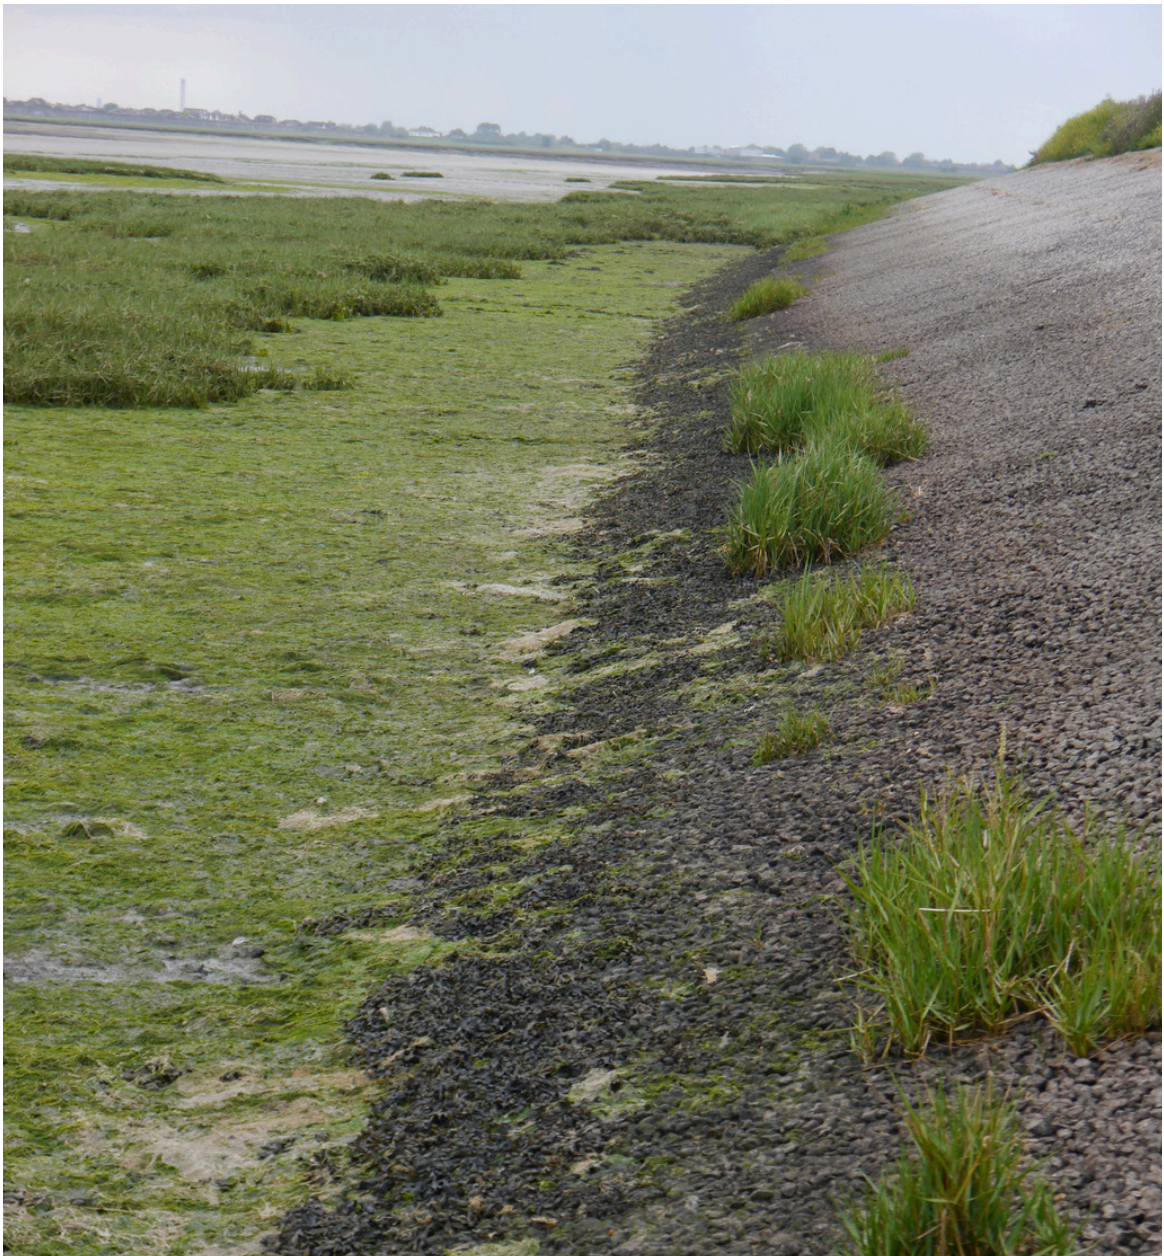
| Photo Ref | Location | Date Installed | Material | Notes |
|---|---|---|---|---|
| TT Is -A | Two Tree Island, Essex | August 2005 | 20-32mm OSA | Bladder Wrack well established along lower part of revetment |

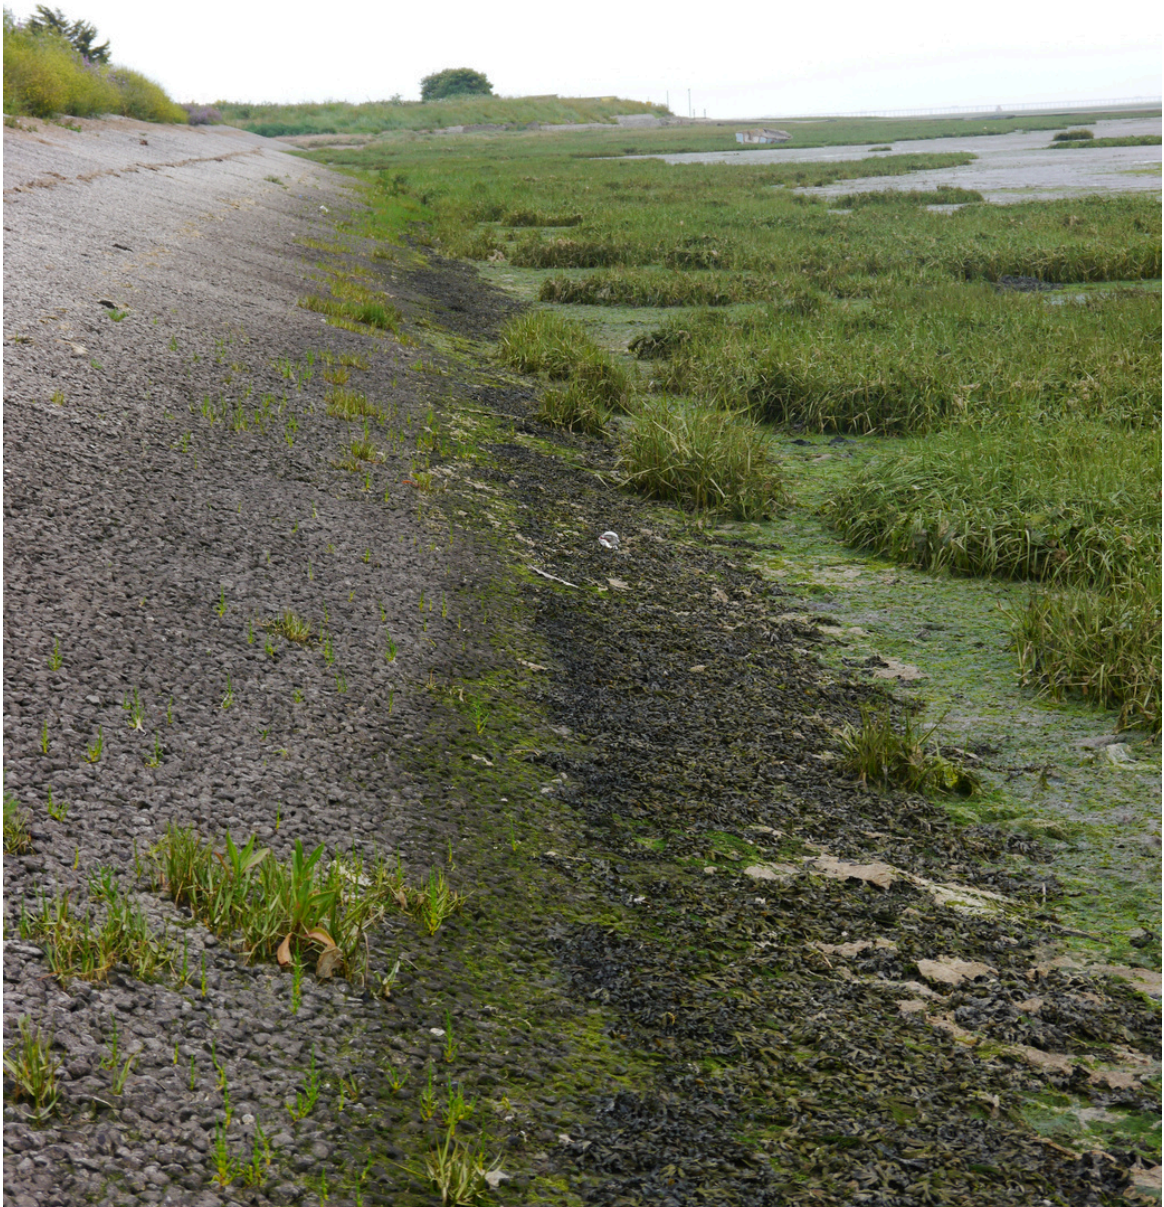
| Photo Ref | Location | Date Installed | Material | Notes |
|---|---|---|---|---|
| TT Is -B | Two Tree Island, Essex | August 2005 | 20-32mm OSA | Bladder Wrack well established along lower part of revetment |

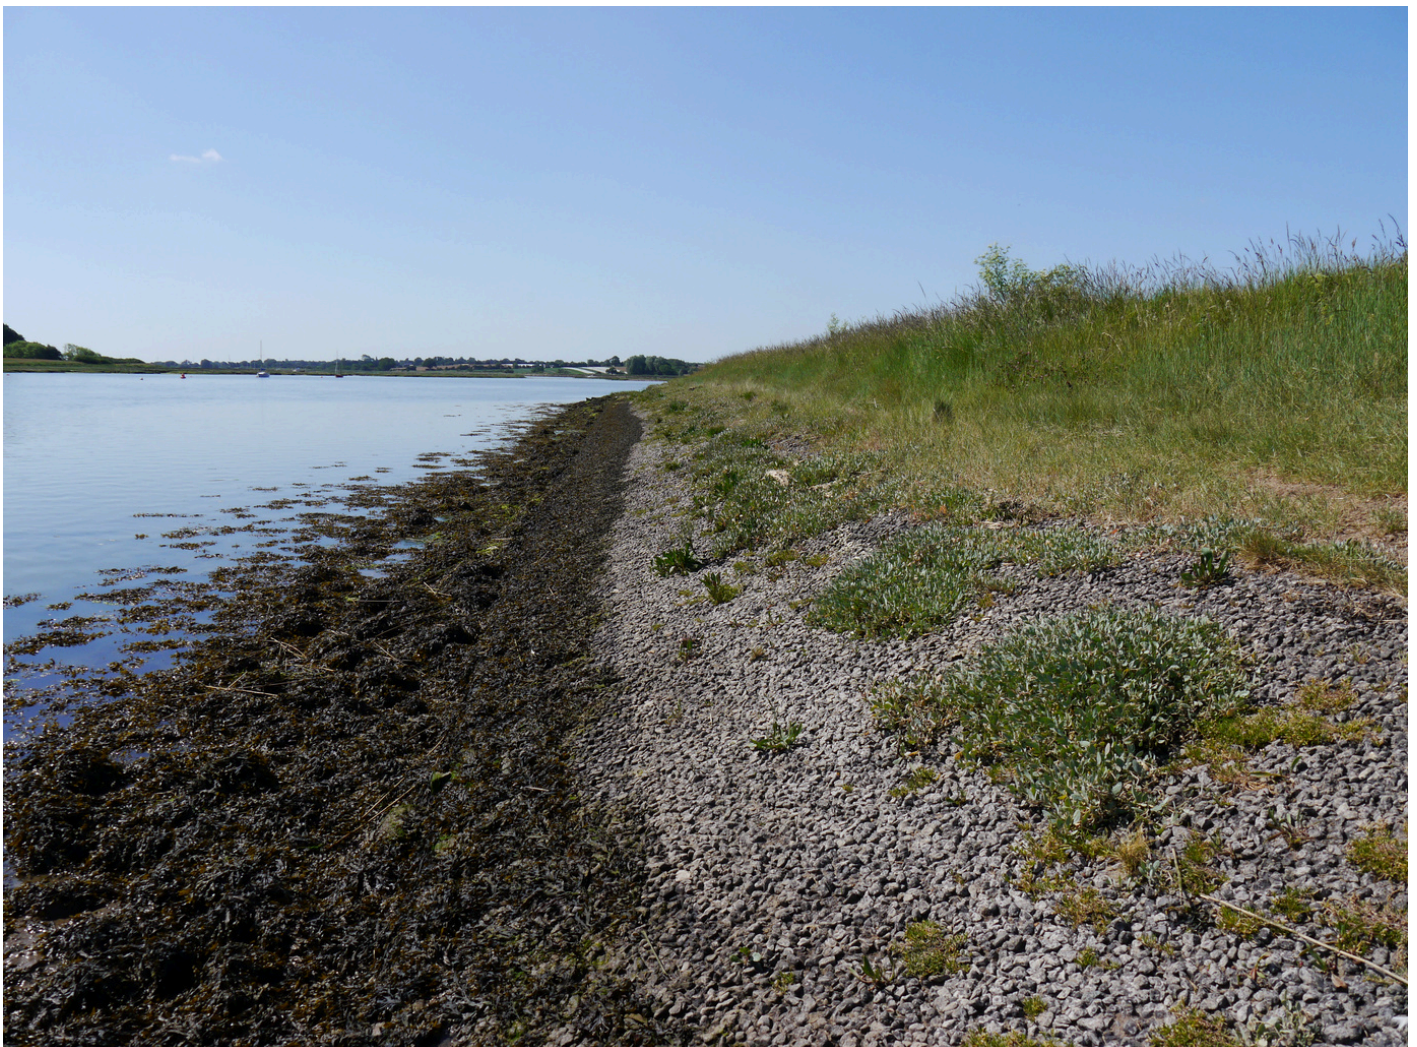
| Photo Ref | Location | Date Installed | Material | Notes |
|---|---|---|---|---|
| Wood - A | Woodbridge, Suffolk | September 2010 | 20-32mm OSA | Bladder Wrack well established along lower part of revetment |

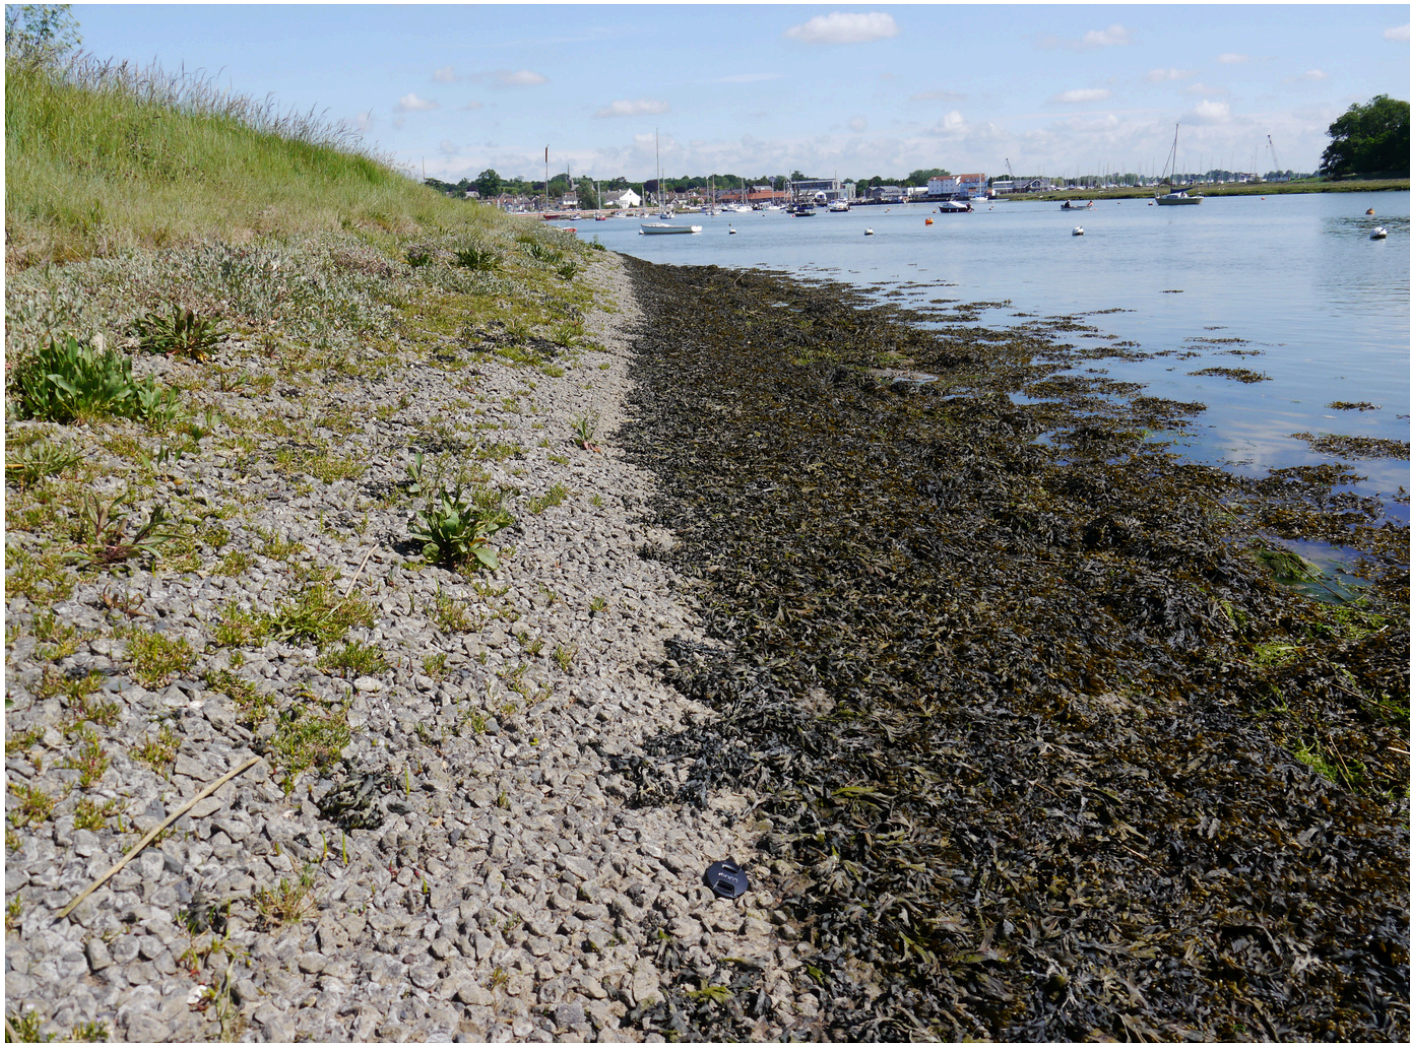
| Photo Ref | Location | Date Installed | Material | Notes |
|---|---|---|---|---|
| Wood - B | Woodbridge, Suffolk | September 2010 | 20-32mm OSA | Bladder Wrack well established along lower part of revetment (camera lens cap -55mm - included for scale) |
